Appendix H: Marine Infrastructure

2.0 Existing Situation

Table 1: Water Access within Study Area

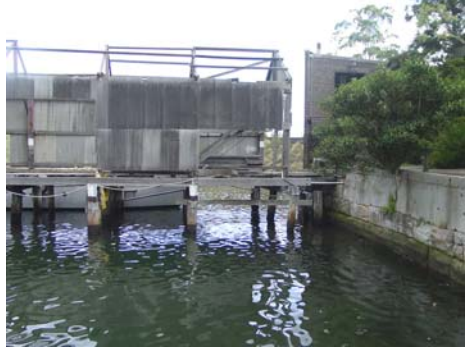
Location	Description	Condition ¹	Ownership	Image
Adjacent to No 1 Bank Street	Timber jetty, now disused.	Poor – incomplete roof	The land over which the jetty is built belongs to the NSW Maritime.

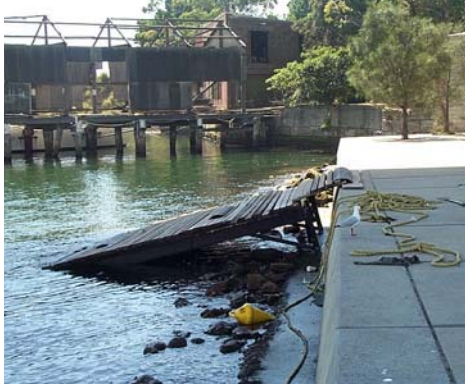
Northern end of NSW Maritime site	Make-shift timber ramp installed by Dragon Boat users, who currently hold a month-by-month lease for use of the site.	Appears unstable and temporary	The land over which the ramp is built belongs to the NSW Maritime.

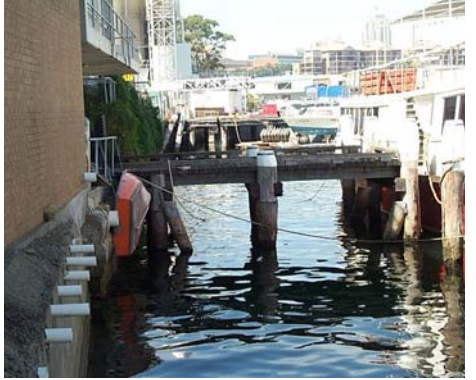
Bidvest Site	Small timber jetty, with just one boat, the <i>Martin Cash</i> , moored there. Not used for regular deliveries, etc.	Unknown	The land over which the ramp is built belongs to the NSW Maritime, the jetty belongs to Bidvest

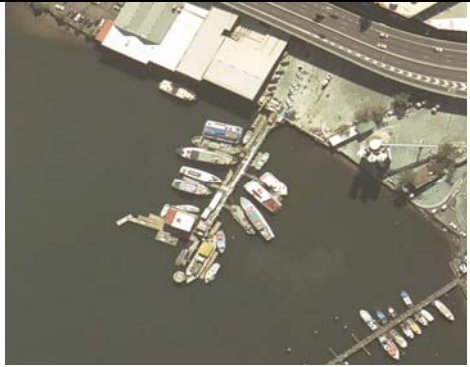
Location	Description	Condition ¹	Ownership	Image
Charter Boat Wharf at Hymix north.	Timber deck, sub-structure, piles and fender piles	Poor state of repair – requires maintenance	The land over which the ramp is built belongs to the NSW Maritime, the jetty is leased to Hymix

GHD's *Marine Infrastructure Overview* (2002) claim the 'walls adjacent to ... Hymix and the Charter Boat site may have unacceptable low factors of safety² against collapse, and immediate further structural safety investigations are recommended'. Hymix advise that improvements to the seawall are proposed.

- The generally poor condition of existing marine infrastructure is a significant constraint;
- The remaining service life of the Charter Boat Wharf was assessed at 5 years in 2001. Assuming that a facility of this nature is required, this structure should be withdrawn and replaced with an appropriate new structure;

- In addition to addressing the present public liability risk to the owners (NSW Maritime), replacement of the Charter Boat Wharf could be an opportunity to provide services not presently available to floating craft such as sewage pump-out facilities, removal of waste oils and lubricants, water and electricity supply, although these facilities are possibly to be implemented as a part of the draft SFM Master Plan.
