## 6 Maritime archaeological investigations and assessment

## 6.3 Results and assessment

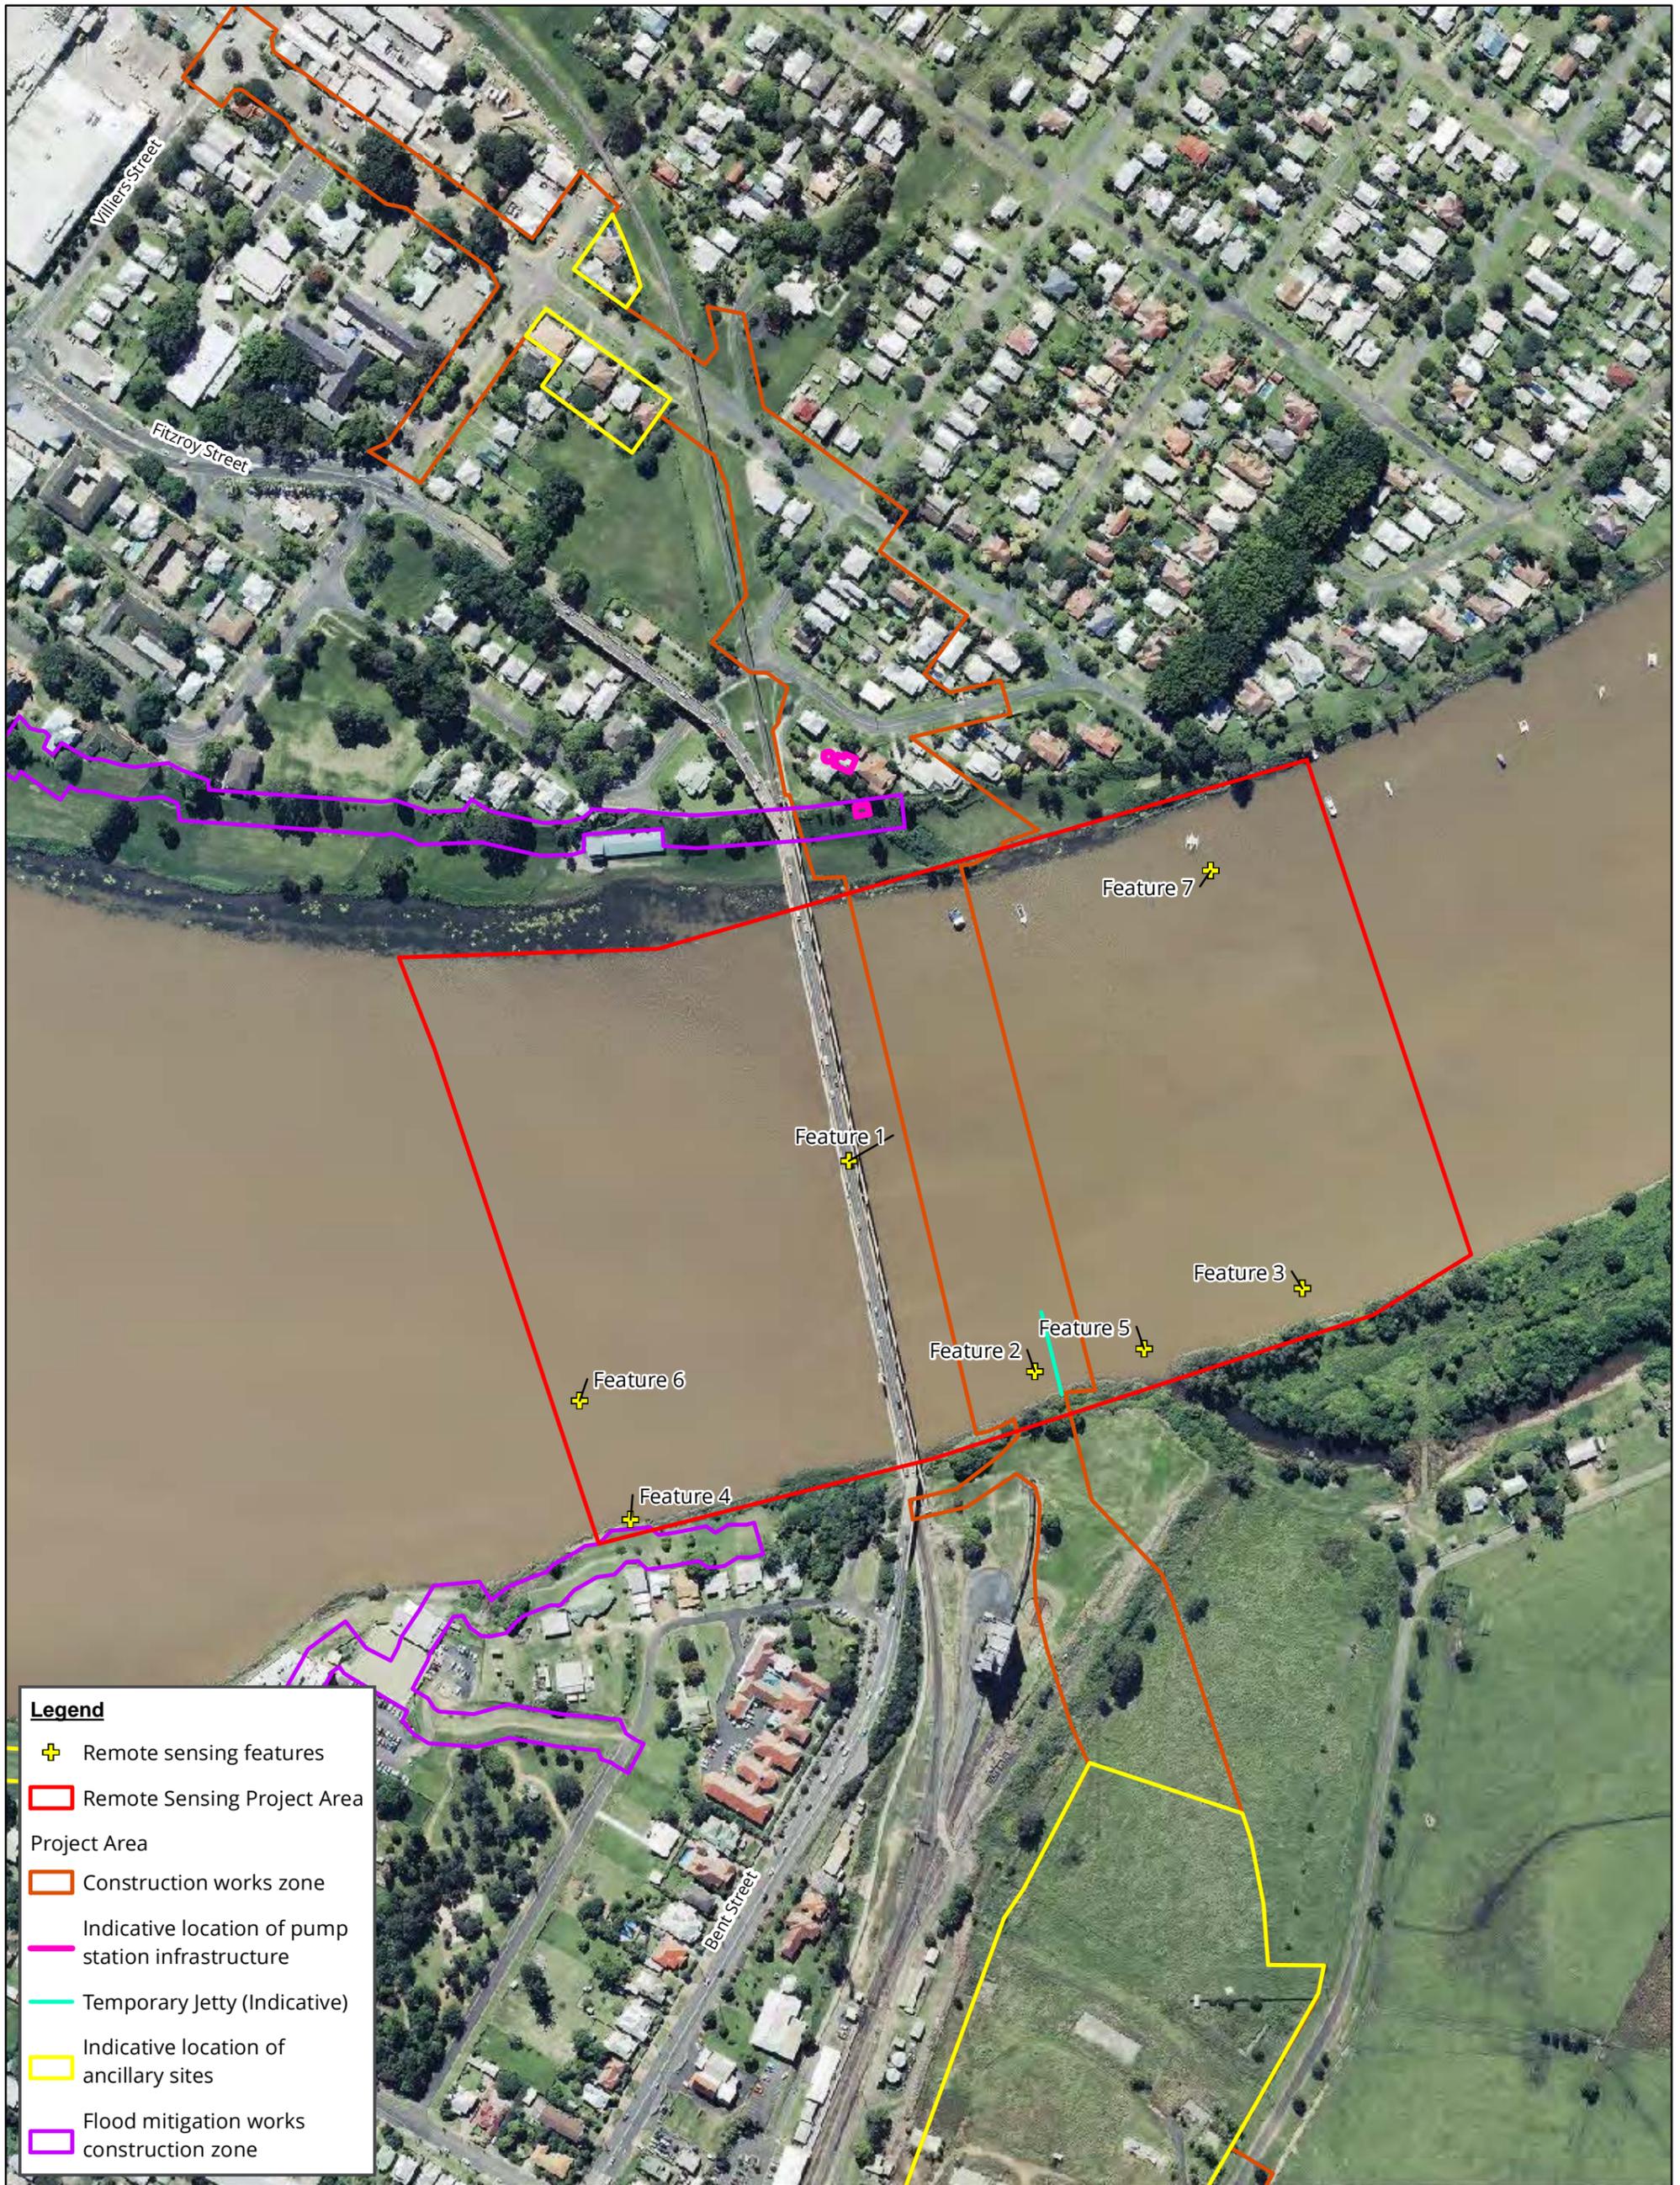
Figure 29: Results of the Remote Sensing Survey

Seven features were identified as a result of the remote sensing survey, these are summarised in Table 25 and displayed in Figure 29.

Feature	Result	Assessment
1	This feature is around 1.2 metres in length and rises 0.8 metres from the river bed. It does not appear in the sub-bottom profile imagery, suggesting that it is insubstantial and not attached to additional structure.	This feature was not considered to contain any archaeological potential and was not included in the dive survey.
2	This is an angular contact 1.5 metres height 2 metres length consistent with a concrete block or similar and likely associated with what appears to be pylons from an adjacent derelict wharf immediately north of the South Grafton Rail Precinct (CZB37) and Grafton Bridge construction area (CZB36) and west of the entrance to Alipou Creek. There is a high concentration of debris in this area.  The proximity to a former wharf site (CZB36) makes this an area with potential for deposition of wharf infrastructure remains and equipment associated with the transfer of goods and services across the river.	This feature was considered suitable for inclusion in the dive survey to confirm the nature of the object and of the adjacent debris.

3	This 1 metre x 1 metre angular contact is located adjacent to the former wharves (CZB36) east of Alipou Creek. It is consistent with a concrete block or similar sighted along the shoreline of south bank.	This feature was considered suitable for inclusion in the dive survey due to confirm its identity and relationship to the original wharf structure.
4	This is an area associated with the wreck of the <i>SS Induna</i> (FMW29). The debris field could include structural remains of the ship and/or remains of an associated wharf (FMW28).	If these objects are associated with the <i>SS Induna</i> they share that ship's listing status on the SHR. This area was included in the visual inspection to determine the nature and extent of the objects and their relationship to the <i>SS Induna</i> (FMW29). An inspection and assessment of the condition of the submerged section of the ship's hull.
5	This is a linear contact, 1 metres in length, at the entrance to Alipou Creek. It is consistent with metal rod or similar.	Due to its proximity to the former wharves (CZB36) it was included in a survey of the south bank area east of the bridge in order to assess its archaeological potential.

6	This linear contact is 30 metres in length and consistent with cable, chain, rope or similar. It may be associated with a communication cable or with the construction of the bridge.	This feature was not considered to contain any archaeological potential and was not included in the dive survey
7	This linear contact is the only feature identified on the northern side of the river. It is 9 metres length and consistent with rope. It is believed to be discarded anchor or mooring line from recreational boats in the area.	This feature was not considered to contain any archaeological potential and was not included in the dive survey.

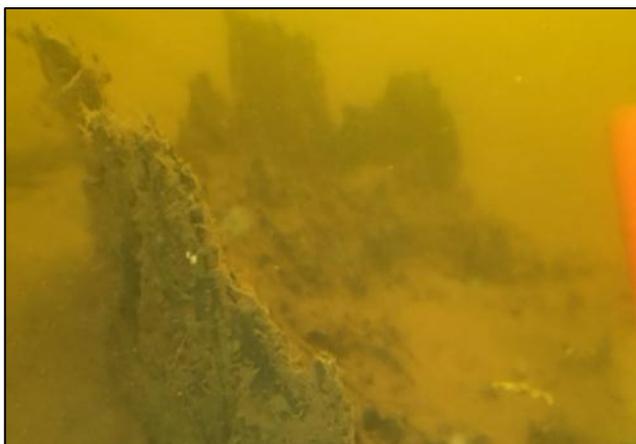
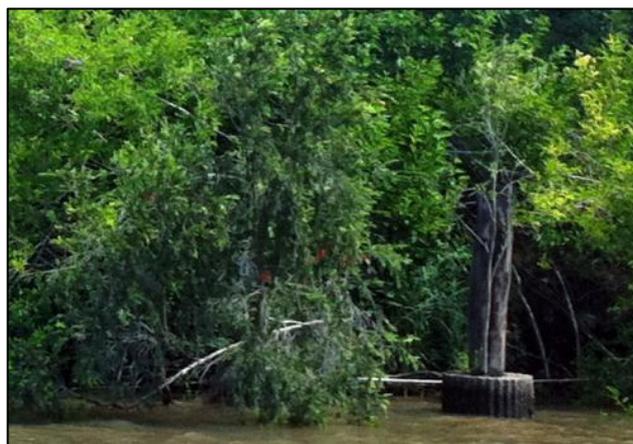
The wharf remains include two hollow concrete pylon sleeves with a corrugated outer surface lying end to end. Half of a third concrete sleeve, split open longitudinally, was also observed. Each concrete sleeve is about 3.15 metres in length. They are identical in construction to the pylons that are visible above water at the edge of the river. The concrete formed a sleeve around a central timber pole, however the timber has rotted away leaving the hollow centre. An upright piece of one timber post of similar dimension (0.3 m) was visible on the riverbed (see Plate 54).

**Plate 54: Remains of a timber post (left) and (right) Exposed remains of timber post with concrete sleeve at base near river bank – showing corrugated outer surface of the sleeve (Source: Comber Consultants)**

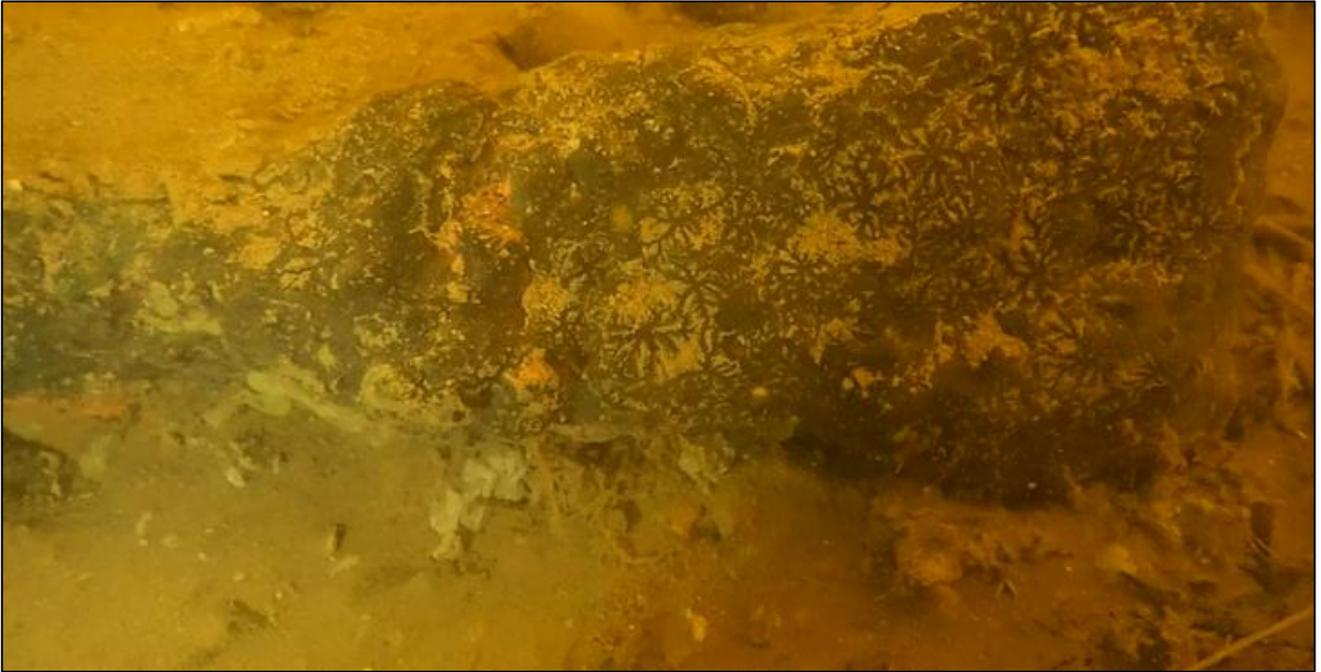
Mattocks and picks lie west of the concrete pylons and are massed together in heaps of six or more. The timber handles were occasionally present (see Plate 55). The tools appeared to have been dumped as a group. Elsewhere, also in about 5 metres of water, are a number of timber beams with metal fastenings or bolt holes which appear to be the remains of the wharf. These timbers run parallel to the shore line (see Plate 56). The items encountered at Feature 2 are common in nature and therefore have been assessed as not being a relics or heritage items.

**Plate 55: Mattock blade at remote sensing Feature 2 (Source: Comber Associates)**

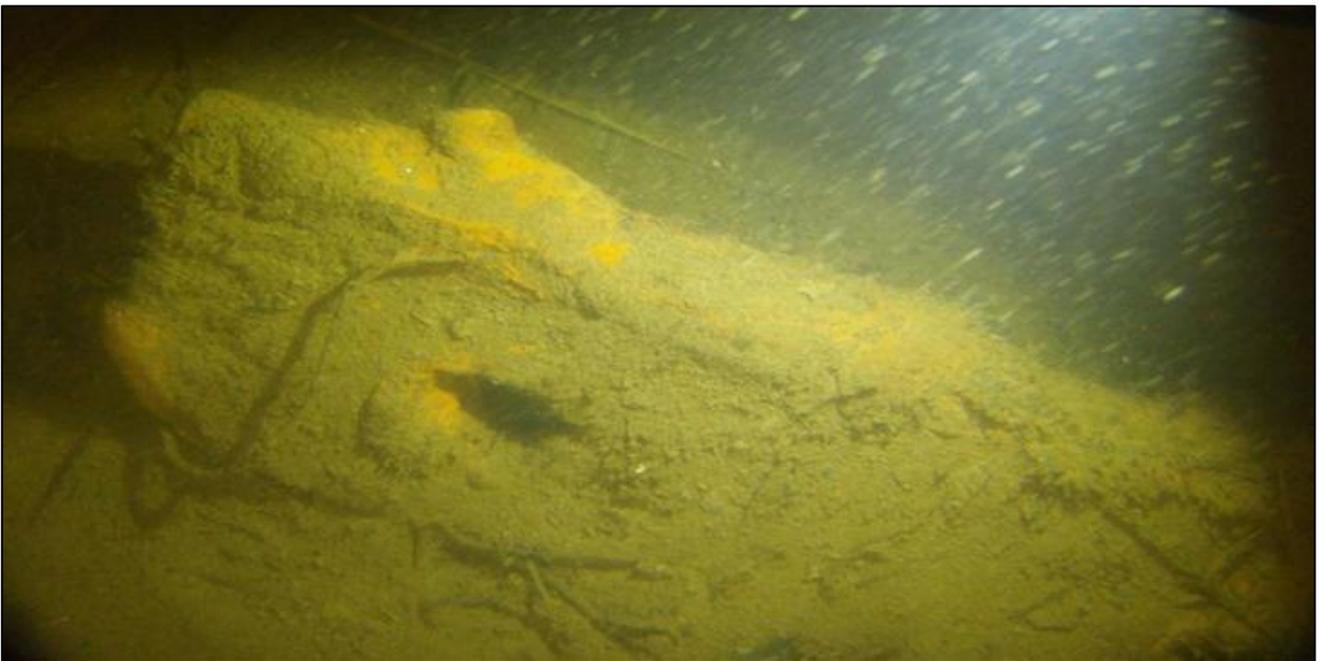
**Plate 56: Wharf timber at remote sensing Feature 2 (Source: Comber Associates)**

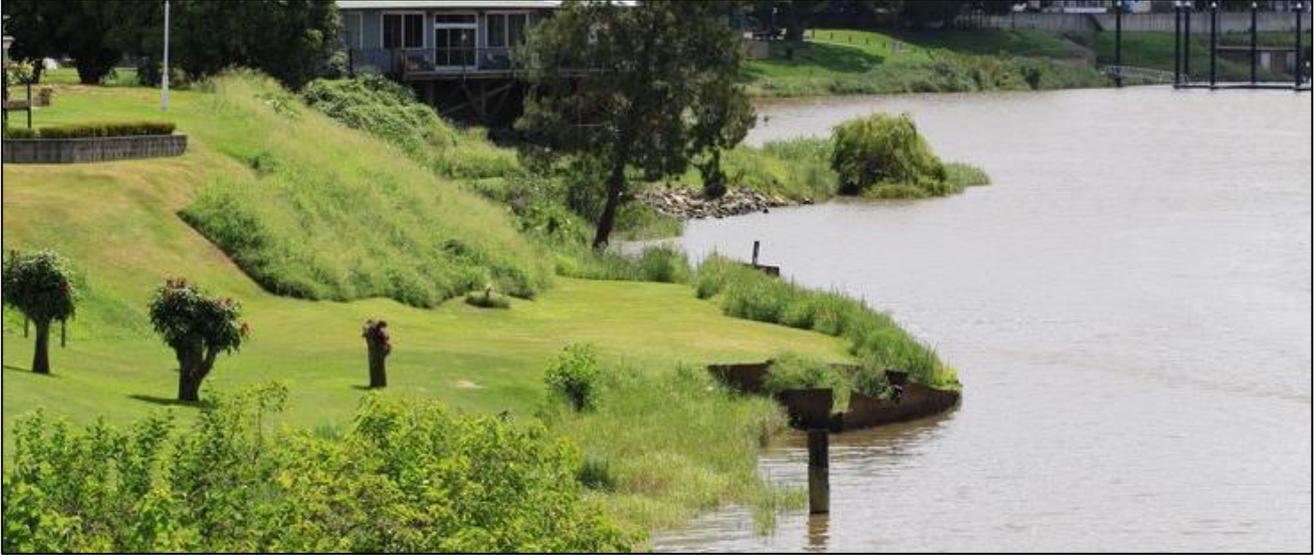
Underwater, the debris field is restricted to the length of the ship (about 58 metres) and about 6 metres northwards from the port side of the hull (see Plate 57). Most of the debris was within 3 metres of the hull. With the exception of one and a half house bricks the debris field consisted entirely of ferrous metal associated with the *SS Induna* which appears to have fallen into the river prior to or during the removal of the ship's superstructure in 1972. This included rectangular sections of iron plate, one of these was 3 metres in length and about 1 metres in width. A five metres section of frame was located near the stern of the *SS Induna* (FMW29) and frame sections as well as a couple of 1.5 metres sections of 40-50 millimetres diameter ferrous pipe. A 1 metres long, 0.3 metres diameter ferrous cylinder with a 50 millimetres diameter pipe running through the centre of the cylinder was also located in this area. A 0.4 x 0.3 metres moulded, oval ferrous cover, possibly off a pressure vessel, was located about 3 metres north of the stern. The site also included a single ferrous bolt of about 160 millimetres in length.

**Plate 57: Western facing photograph of the *SS Induna* (FMW29) which clearly shows the embankment extending over *SS Induna* hull and the proximity of the existing levee (Source: Comber Consultants).**

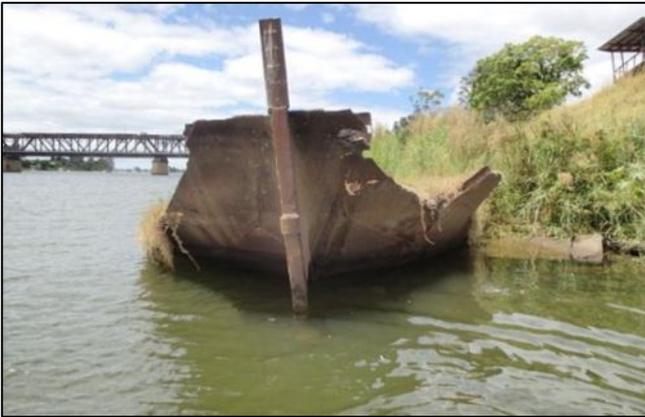
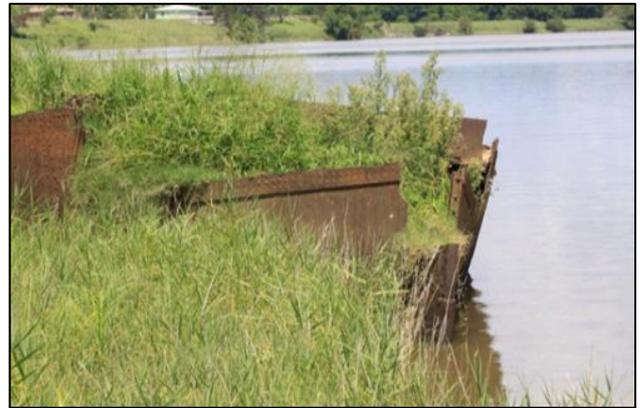
**Plate 58: East facing photograph of the stern of *SS Induna* (FMW29) (left) and (right) bow area where bow was removed for nearby memorial (Source: Comber Consultants).**

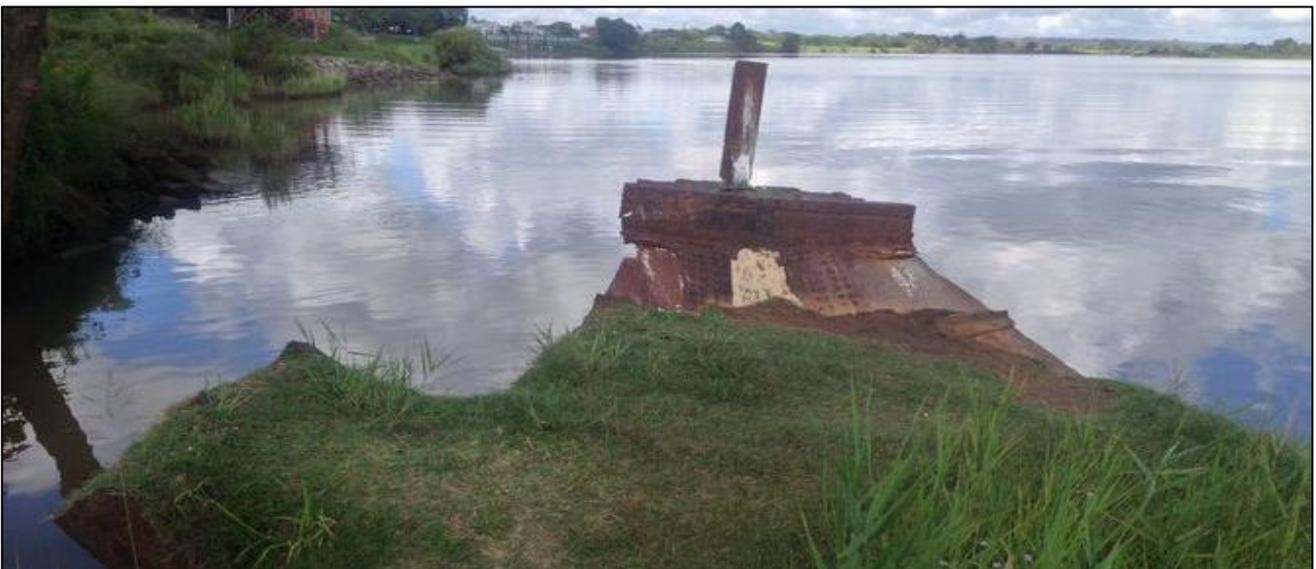
**Plate 59: West facing photograph of the stern of the *SS Induna* (FMW29) (Source: Comber Consultants)**

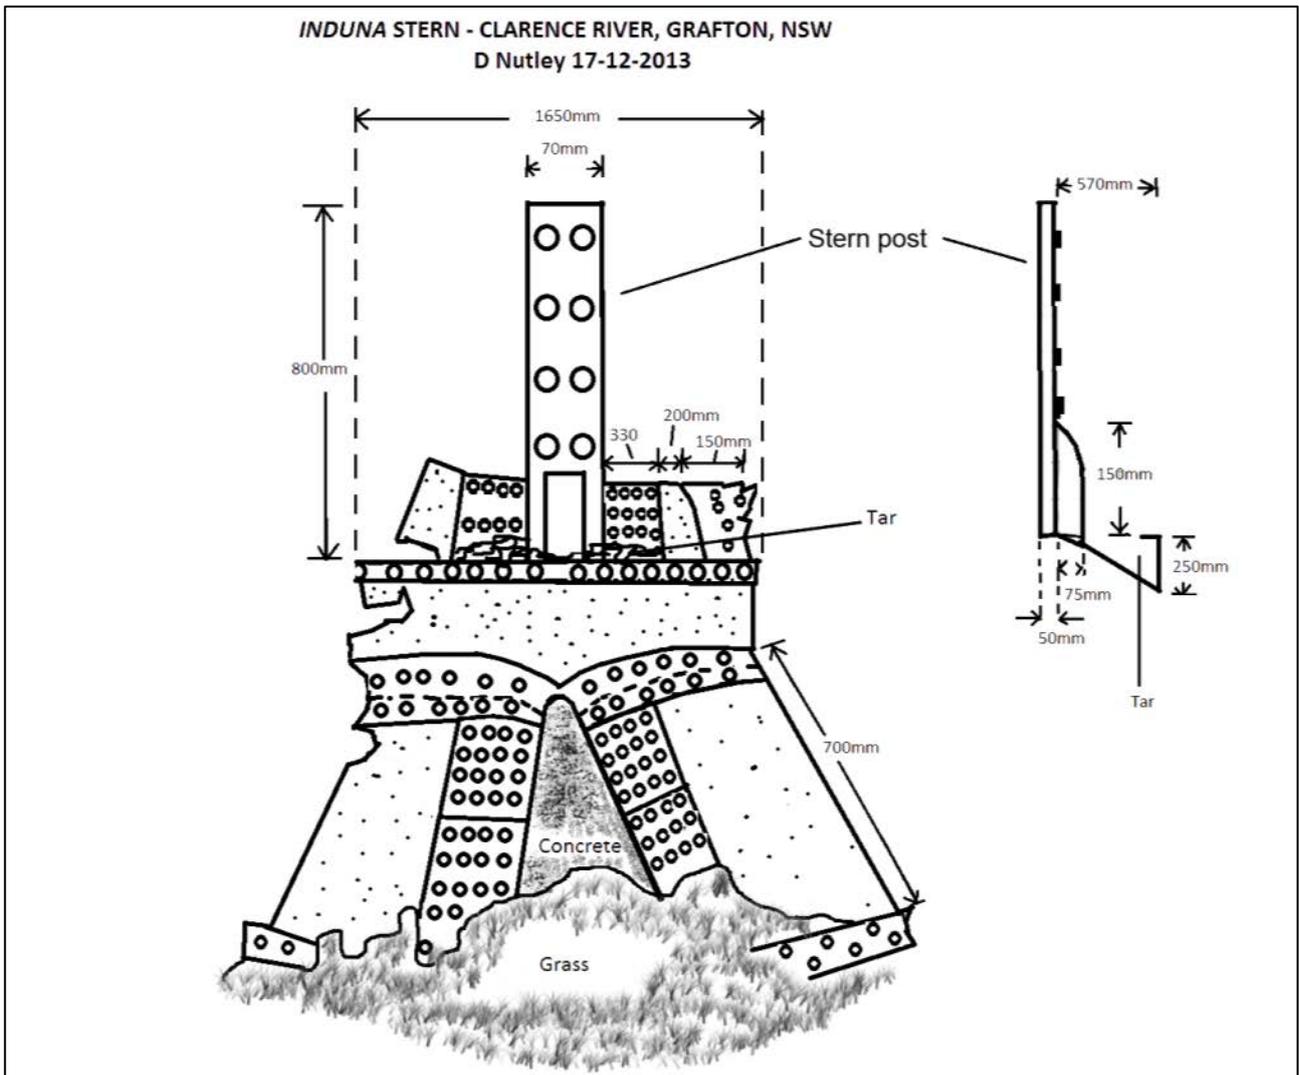
The lower hull of the *SS Induna* is clear of the seabed. Due to the confined space, safety concerns and limited visibility, the full extent of the hull clearance could not be established but, based on observations at the bow and stern and the limit of torch light penetration at mid-ships, the clearance appears to be about at least as far as the keel (see Plate 58 and Plate 61). The submerged bow and stern sections of the port hull were in good condition. Amidships, however, there were six large openings between the hull frames and above the turn of the bilge. Each opening is about 1 metres in height and 0.7 metres in width. This appears to be the result of natural corrosion of the hull plating in an oxygenated area that is periodically exposed to wetting and drying.

Plate 61: Raised and exposed stern section of the SS *Induna* (FMW29). View to the west from inside the hull (Source: Comber Consultants).
