SOUTHBOUND BRIDGE OVER THE SHOALHAVEN RIVER IN NOWRA

Structural inspection and assessment
Summary report

SEPTEMBER 2014

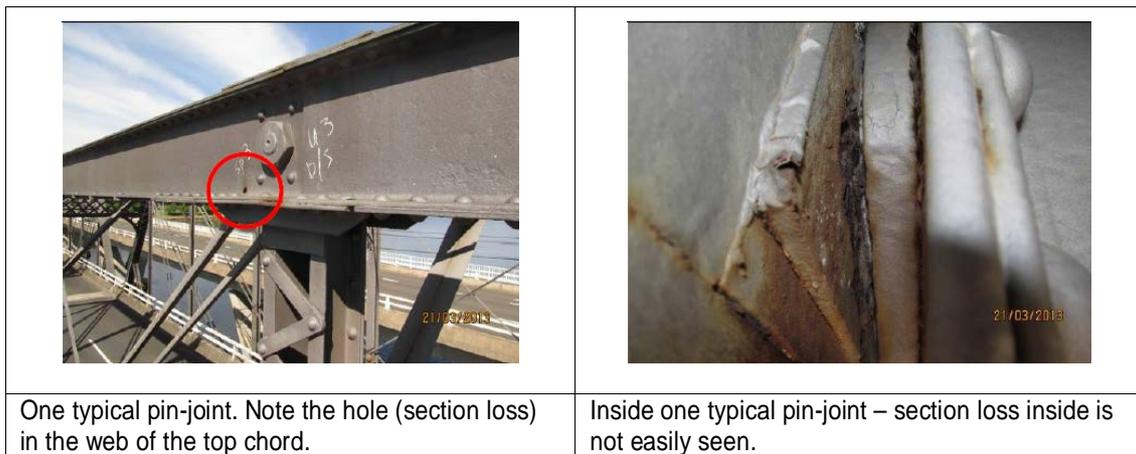
Figure 3 Images from the old bridge showing corrosion at pin joints along the top chords

At most pin joints along the top chords, there is internal corrosion within the chords, probably caused by an accumulation of salts. In a few places, the corrosion has created holes (known as 'section loss'). There is also corrosion on the side plates. If the corrosion is left untreated, the joint will lose strength and will not be able to support the required loads.

Forty-five of the 118 pin joints at the top chords are in poor condition and need to be repaired or strengthened, although no joints have failed. Most other pins appear to be in fair to good condition.

- Wash off the accumulated salts at all joints
- Strengthen all those joints that are in poor condition by installing side plates
- Paint all joints with a protective treatment to prevent further corrosion
- Repaint the top chords and truss principals.

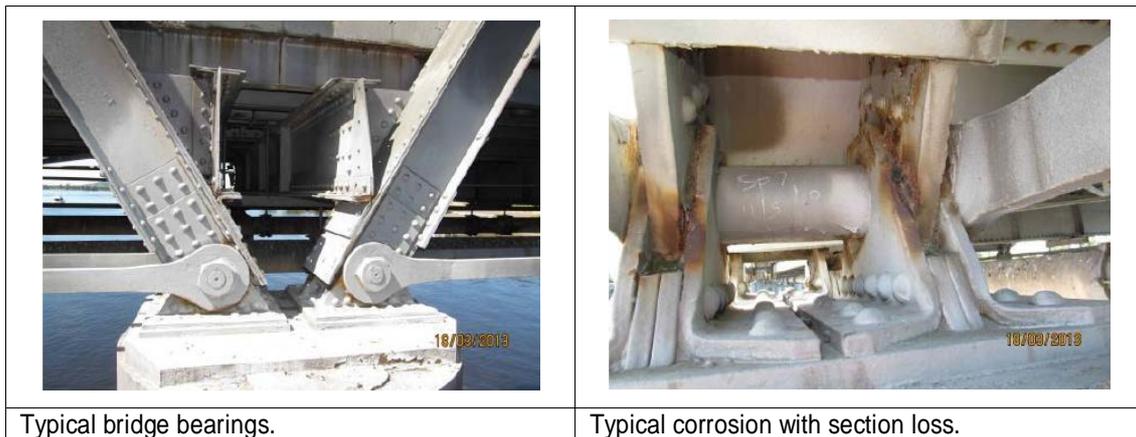
Figure 4 Images from the old bridge showing corrosion of bridge bearings

The end diagonals or 'principals' of the trusses take the load down to the supports (that is, the bridge bearings). Many of these bearings are corroded and in poor condition. Some have section loss. There is also section loss at the truss principals. In addition, on some of the piers, the expansion bearings are not moving as they are designed to do. Typical bearings are shown in the photographs below.

- Clean off the corrosion
- After cleaning, inspect the area to determine if any areas of section loss require repair
- Paint the area with a protective treatment to prevent further corrosion
- Carry out maintenance on the expansion bearings so they move as designed.

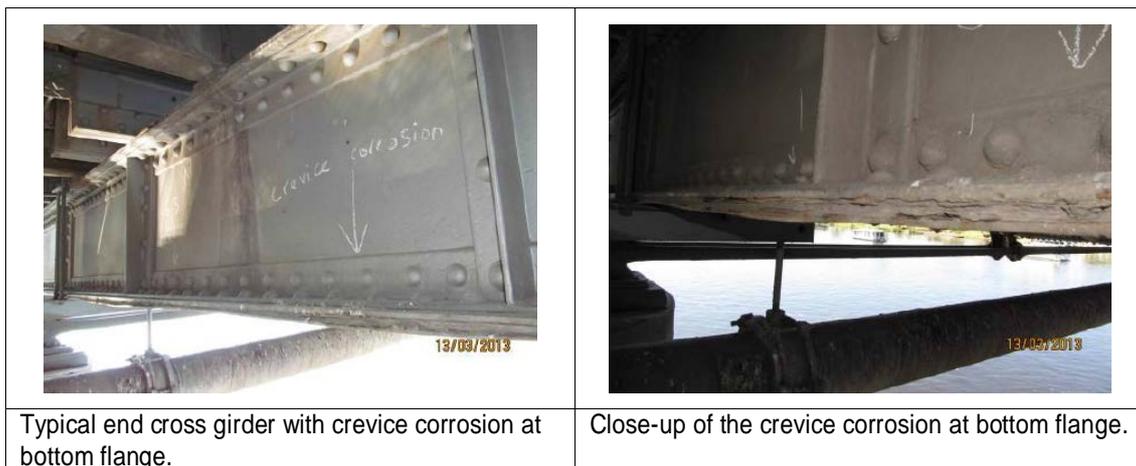
Figure 5 Images from the old bridge showing corrosion of end cross girders on truss spans

The end cross girders are showing varying degrees of corrosion at the top and/or bottom flanges. This type of corrosion affects the bending capacity of the girder. As a conservative estimate, the bending capacity of all end cross girders on the bridge is downgraded by 30%.

The girders are generally in poor condition but still appear to be performing satisfactorily.

Ideally, these cross girders should be replaced or strengthened. However, this is not easily done without disrupting traffic. Therefore, a realistic approach would be to:

- Consult expert advice

- Monitor these girders for signs of distress or deterioration, and repair or strengthen them if necessary.

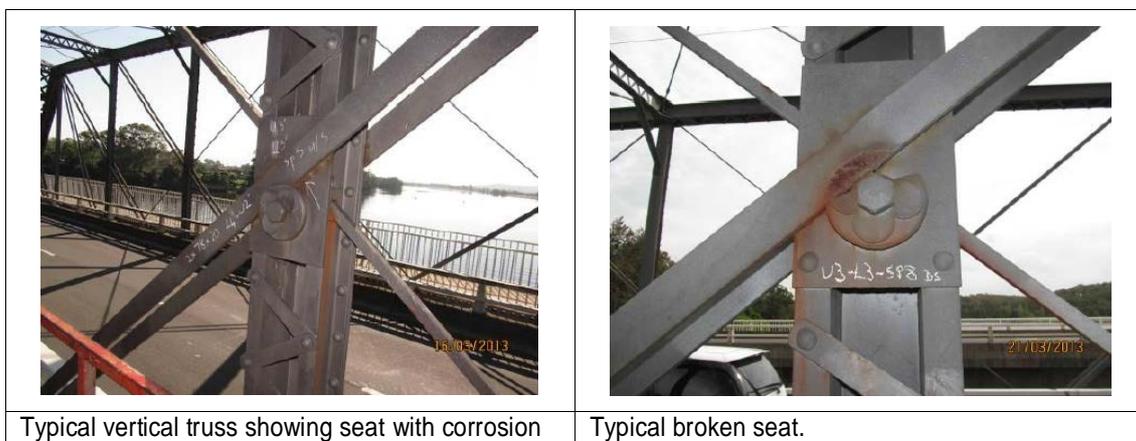
Figure 6 Images from the old bridge showing broken cast-iron seats on the trusses

Where a diagonal brace crosses the vertical truss there is a washer or 'seat' which holds the diagonal to the vertical and stops them vibrating. There are a number of issues with the seats:

- Some of the seats are broken and need to be replaced
- Some diagonals have turnbuckles (bolts) that have come loose and need to be tightened
- Some seats (washers) are corroded
- Some diagonals have moved and are no longer attached to the seats.

- Replace all broken seats
- Move diagonals back to their original location and reattach them to their seats
- Tighten turnbuckles that have become loose
- Paint the area with a protective treatment to prevent further corrosion.

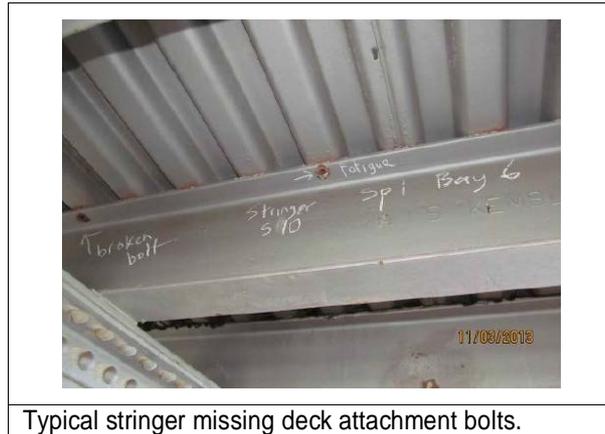
Figure 7 Images from the old bridge showing broken attachment bolts between stringers and the deck

The steel decking is attached to the stringers by bolts. The main issue is that the attachment system does not sit evenly on the stringers. When traffic travels on the deck, the deck flexes, and this flexing causes high stresses at the attachment points. The attachments have fatigued and the weakest elements (the bolts) have failed. Some bolts are missing.

Typical stringer missing deck attachment bolts.

- Design and install a new and more flexible attachment system to hold the deck to the stringers. This will reduce the stresses in the attachment bolts and make the attachment more durable.

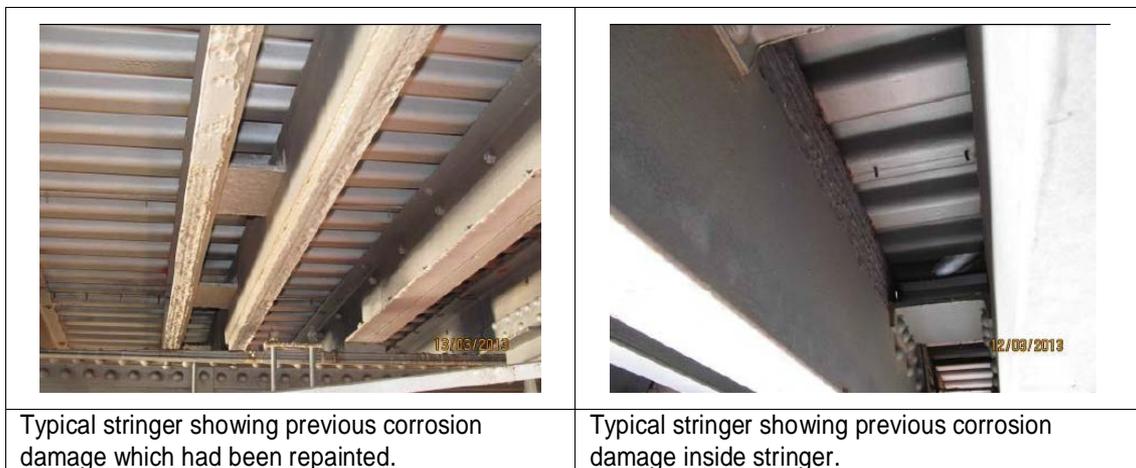
Figure 8 Images from the old bridge showing corrosion damage on original stringers

The stringers support the deck between the piers. Some of the original bridge stringers are damaged and most have pitting caused by corrosion. Also, some stringers have bent or cracked top flanges. It is very difficult to repair or replace these stringers. As there are 11 stringers between each pier, they do not need to be strengthened or replaced at this stage.

- Continue to inspect the stringers
- If inspections indicate that the stringers are distressed, repairs will need to be carried out to strengthen the stringers.

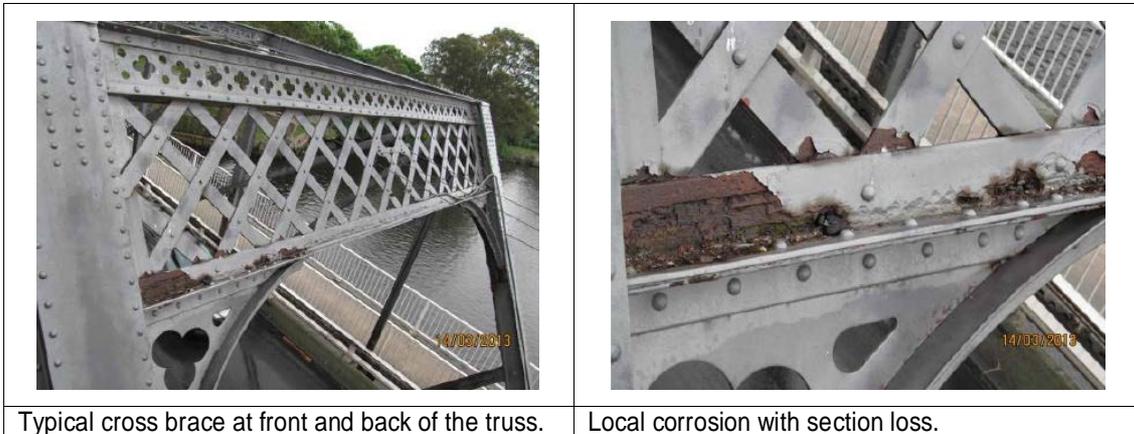
Figure 9 Images from the old bridge showing corrosion of cross braces on trusses

The cross braces have some corrosion with section loss, and there is evidence that over height vehicles have caused some impact damage (such as broken lace and bent angles).

- Design and erect devices to protect the bridge from vehicular impact, especially the front and back cross braces and all truss verticals and diagonals
- Repair the damage on the cross braces
- Paint the area with a protective treatment to prevent further corrosion.
- Design and install systems to minimise the risk of tall vehicles causing impact damage to the bridge.

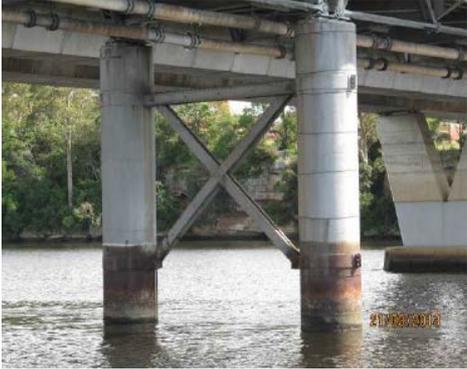
Figure 10 Images from the old bridge showing damaged piers

Piers 3 and 6 are also missing horizontal braces that need to be replaced.

| <p>Pier 3 showing a missing bottom brace. The replacement of the missing brace is recommended as it helps to improve stability.</p> | <p>Piers showing graphitisation.</p> |
