U/W Bridge Inspection

**B 415 Windsor Bridge
Follow-up Inspection
15.6.2011**

RTA Contract No. 10.2535.0889
B 415 Windsor Bridge

B 415 Windsor Bridge over Hawkesbury River, Follow-up inspection

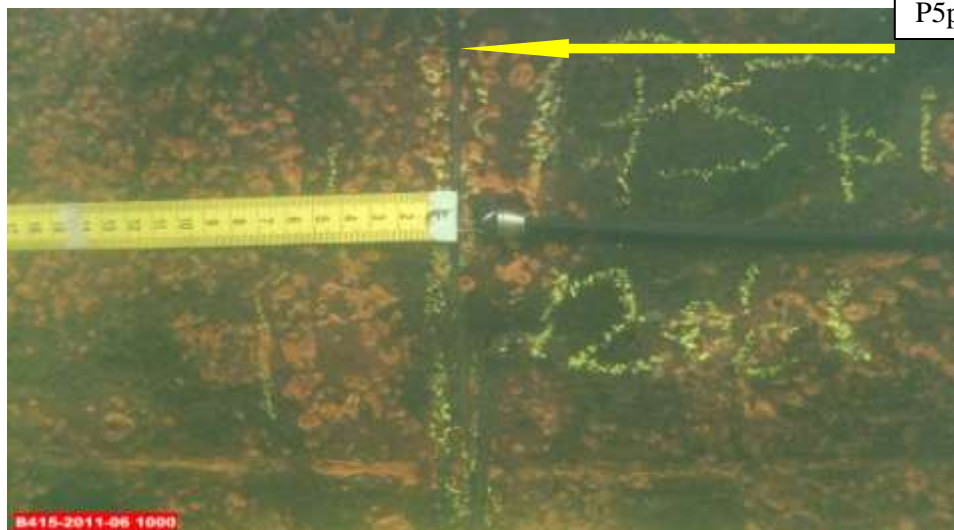
Start of reference tape measure, here P5p2, 12o'clock with reference grind

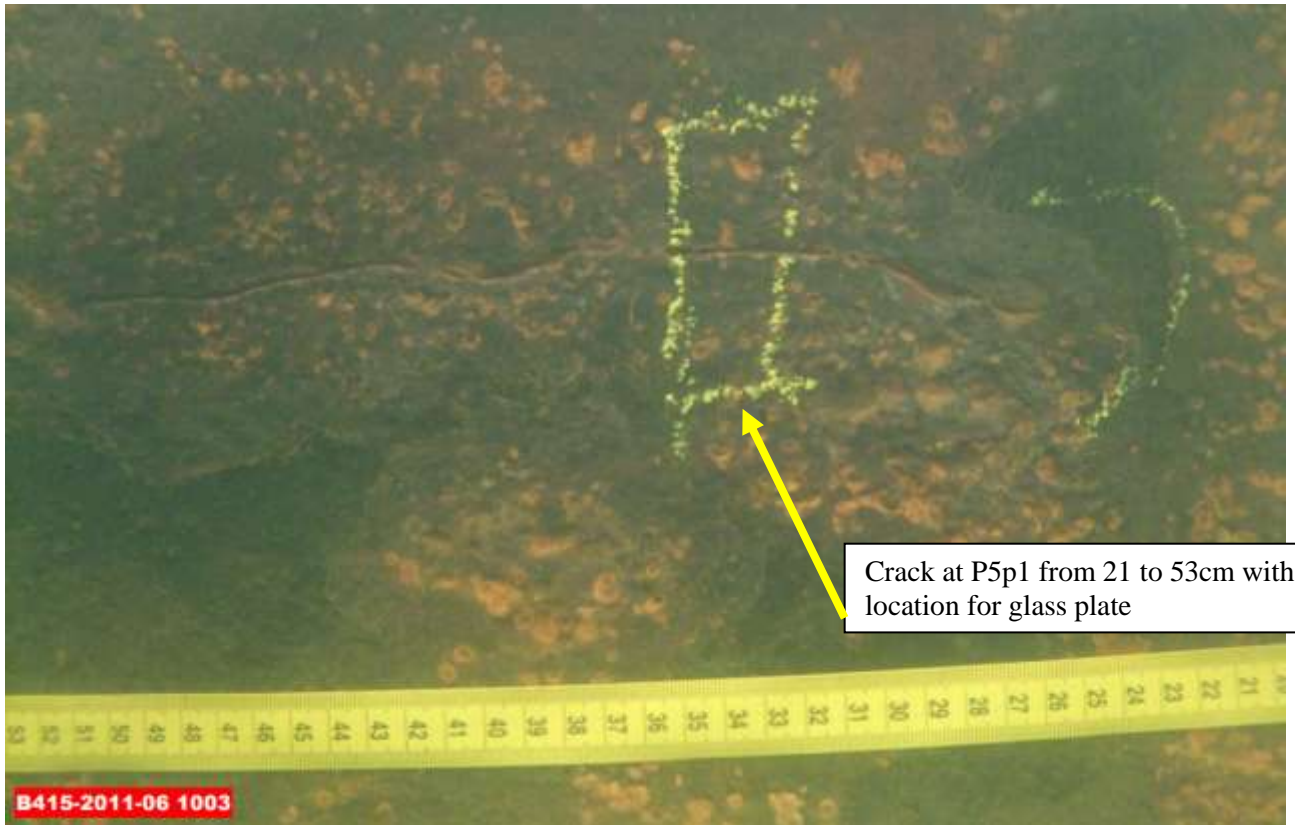
When comparing data and photos from the original inspection (9.4. to 20.4.2011) to this data set which was obtained after the Load Testing of the Bridge, carried out by RTA on the night from 8.6. to 9.6.2011, no evidence appears to be present that the horizontal cracks in piles P5p1, P5p2 and P6p2 have changed, widened or shifted. The same appears to be the case for the small vertical crack in P5p1.

Crack at P5p1 from 21 to 53cm with location for glass plate

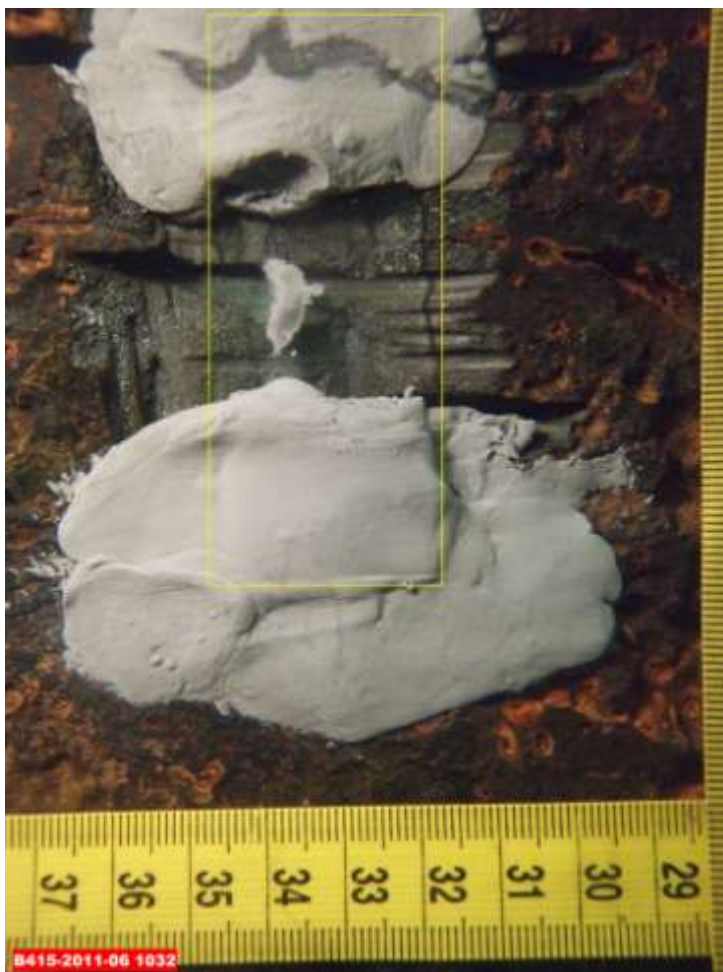
Glass plate on P5p1 at above location

CDS was also engaged to fix a series of 12 glass plates to 4 locations over the cracks on these 3 piles. The 12x glass plates/slides (75mmx20mmx1mm) were attached over the cracks with 2part epoxy in the documented locations.

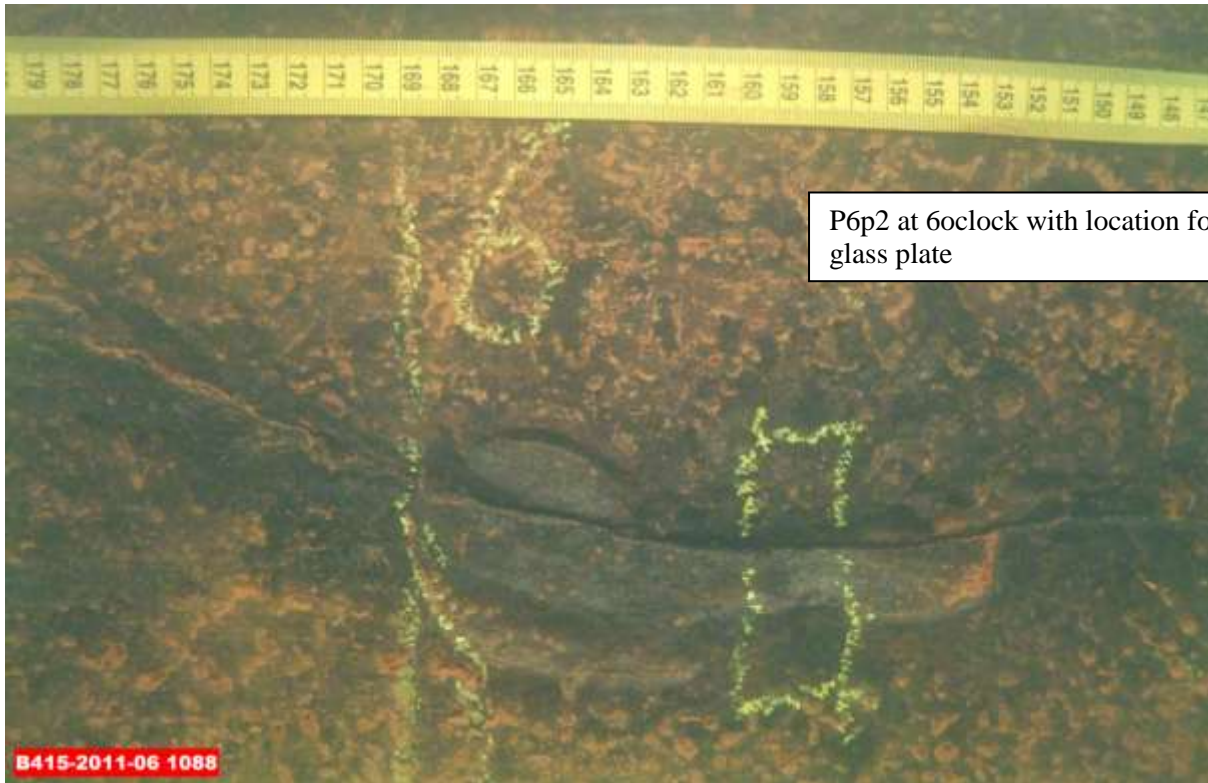
P6p2 at 6oclock with location for glass plate

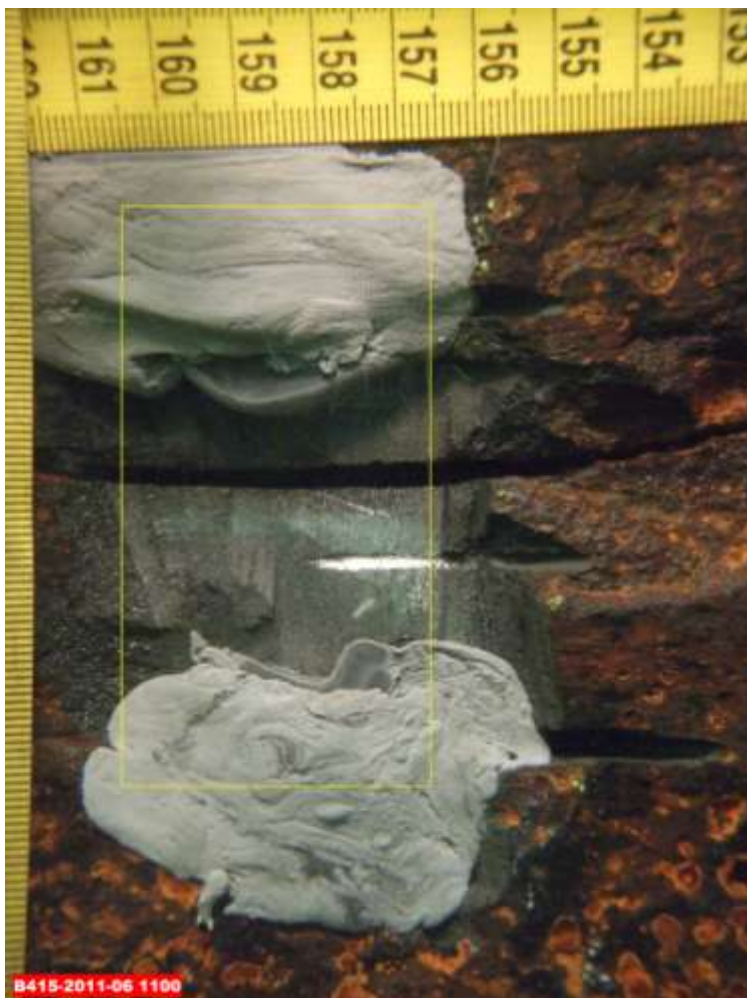
P6p2 with glass plate installed near 6o'clock
