Appendix C – Case studies for outdoor elevators/escalators

Case studies for outdoor elevators/escalators

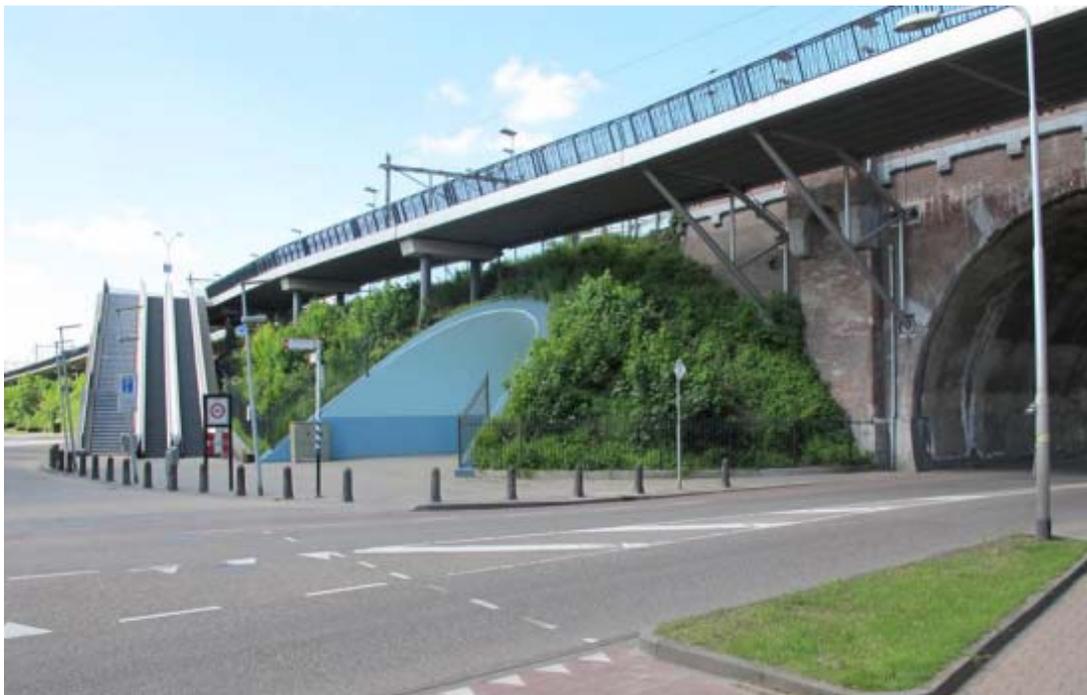
Figure 1 (Out of use) escalator and stair access for cyclists to the Nijmegen Bridge, Netherlands

Description: Outdoor escalators constructed to provide access to elevated cycleway. Completed in 2004.

Issues cited: Poor durability, high cost of maintenance, vandalism, poor reliability, noise, and wheels slipping during and after periods of rain. In 2009, 11 malfunctions were reported. In 2012, the authority responsible for the facility announced their intention to replace the escalators with stairs suitable to be used by cyclists. In this example, provision of an outdoor escalator for cyclists was not considered to be a cost-effective solution.

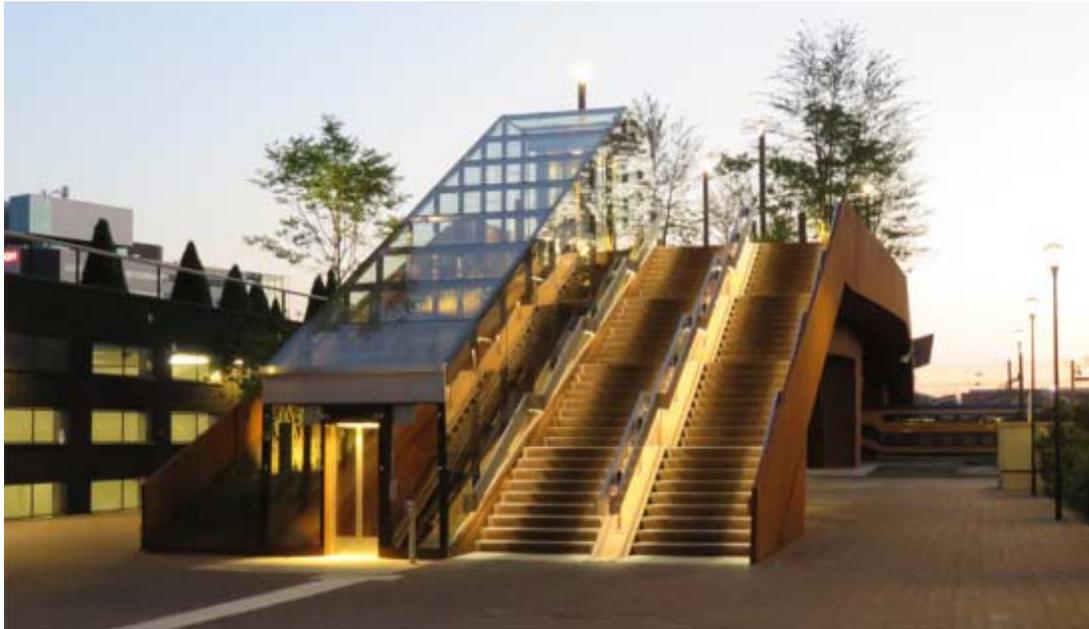
Figure 2 Lift access for cyclists and pedestrians to the Palace Bridge, Netherlands

Description: Inclined lift for pedestrian and cyclist access. Adjacent to the lift are stairs with grooves on the edges to allow cyclists to wheel their bicycles up/down.

Potential issues: A lift would not adequately accommodate the high volume of cyclists currently using the Sydney Harbour Bridge Cycleway. As discussed in Section 2.1.2, data collected in 2014 showed peak hourly demand during the AM and PM periods exceeded 550 and 450 cyclist trips, respectively. Queueing on the bridge deck is also a potential issue as cyclists would be waiting to use the lift at the top of the stairs. Reliability of lifts is also a potential issue.
